Use of Polyethylene Fibre Ribbon Reinforced Composite Resin as Post-Core Build-Up: A Technical Report

TECHNICAL REPORT (TR)

Balk J Stom, 2008; 12:174-177

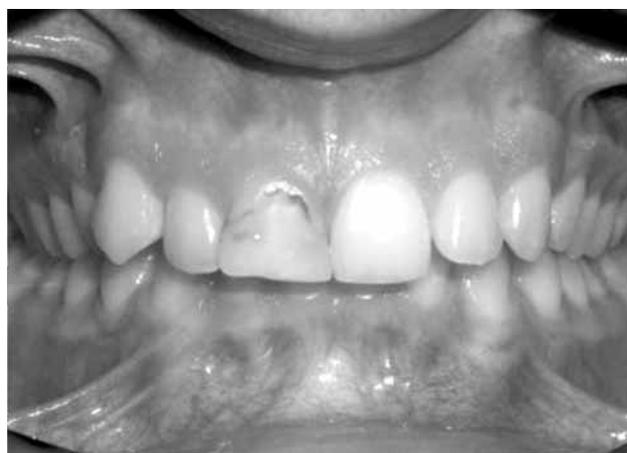
Figure 1. Initial view of teeth

Clinical and radiographic examinations of a 21-year-old male patient revealed a root canal treatment due to the fracture of the maxillary right central incisor, which was restored with composite resin filling materials 4 years ago. The discolouration and secondary caries of the related tooth was not satisfactory for the patient (Fig. 1). Polyethylene fibre ribbon reinforced composite resin as post-core build-up and Empress II crown were planned as treatment options to the patient for replacement of the extensively damaged tooth. The construction of polyethylene fibre ribbon reinforced post-core restoration is not time consuming and provides tooth coloured aesthetic substructure for a complete porcelain crown, which will satisfy aesthetic requirements of the patient.

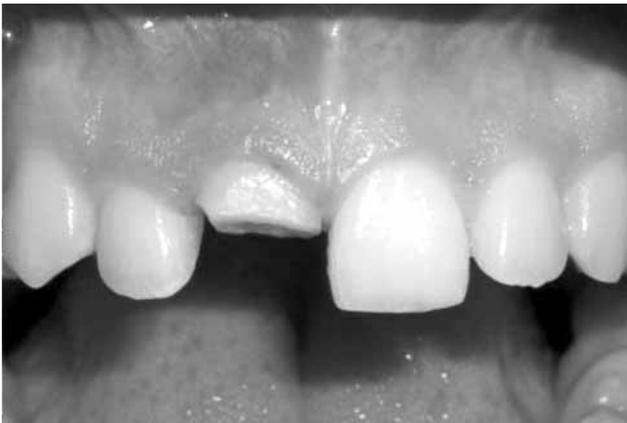
Figure 2A. Remaining tooth structure, after removal of composite resin restoration and caries

The root canal filling was removed to the apical third by using gates glidden and washed with 5% sodium hypochlorite (Fig. 2A and B). After drying procedure with paper points, 37% phosphoric acid was used to etch the root canal wall and remaining tooth surface for 15 seconds, and washed thoroughly for 30 seconds (Fig. 3). Retraction cord (Stay-put; Roeko, Germany) was used to isolate sub-gingival finish line after anaesthesia. Resin cement (Variolink;

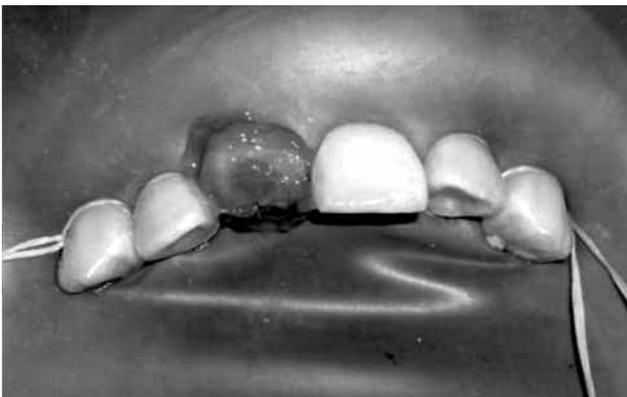
Figure 3. Total etch of the root canal

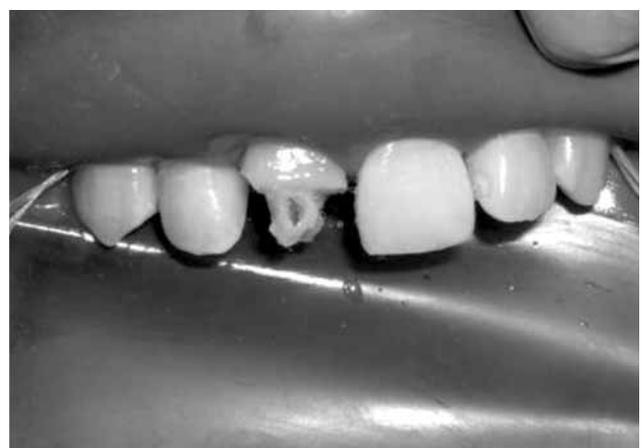
Figure 5B. Forming loop by insertion of free end of fibre ribbon into root canal

The root canal was filled with resin cement. Fibre-resin combination was carefully placed into the canal by use of titanium nitride coated instruments (Brilliant Esthetic Line Composite Instrument, Coltène AG, Switzerland), leaving a loop formed 2-3 mm ribbon above the occlusal surface of the root (Fig. 5A and B). The combined fibre ribbon and luting resin was light cured for 40 sec (Optilux; Demetron Inc, Danbury, Conn). Exposed ribbon loop was then filled and covered with composite resin (Tetric Ceram, Ivoclar Vivadent) incrementally for fabricating core, and light cured for 40 sec from one surface, total of 160 seconds (Fig. 6).

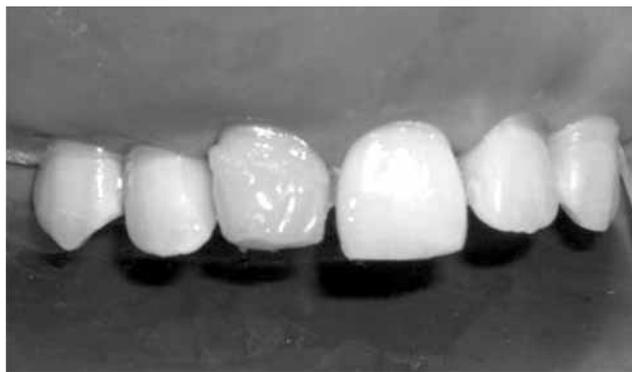
Figure 6. Construction of composite resin (Tetric-Ceram) core

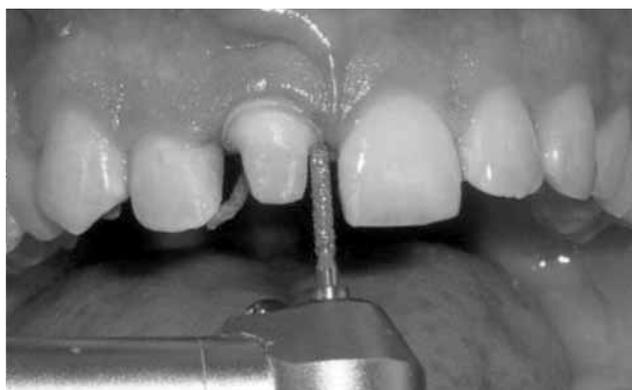
Figure 7. Final preparation for full ceramic restoration

The core preparation was completed with circumferential deep chamfer finish line (Fig. 7). Medium and coarse diamond burs (Accurata, G+K Mahnhardt Dental, Germany) were used for tooth preparations. The width of the shoulder was kept 1 ~ 1.2 mm. Cervical

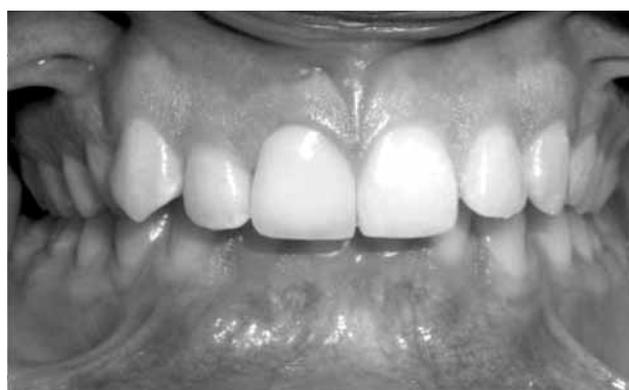
Figure 8. Full porcelain in-situ

The internal surface of the crown was etched with 5% hydrofluoric acid gel (IPS ceramic etching gel; Ivoclar, Vivadent) for 20 sec. A silane coupling agent (Monobond-S; Ivoclar, Vivadent) was applied for 60 sec. The preparation was cleaned with pumice slurry and retraction cord was applied. The core surfaces and remaining tooth surfaces were etched with 37% phosphoric acid (Total Etch; Ivoclar, Vivadent) for 60 seconds. Tooth was rinsed with water and dried. Following the manufacturer's guidelines, Syntac Primer and Syntac Adhesive were applied. The bonding agent was brushed on both preparation surfaces and internal surface of the restoration, thinned with air, and cementation was performed immediately by using Variolink II high viscosity resin cement. Excess cement was removed with brush and dental floss. The restoration was photo-polymerized for 40 sec. from all surfaces, total of 200 seconds. The occlusion was controlled to preclude premature contacts (Fig. 8).
